Subject: Final Report Investigation and Recovery Program for Nozzle Port  
Flange Snap Ring Groove Cracking Problem of the Minuteman Stage III  
Motor, Report No. MTO-752-50

FINAL REPORT  
INVESTIGATION AND RECOVERY PROGRAM  
FOR  
NOZZLE PORT FLANGE SNAP RING GROOVE CRACKING PROBLEM  
OF THE  
MINUTEMAN STAGE III MOTOR

MTO-752-50

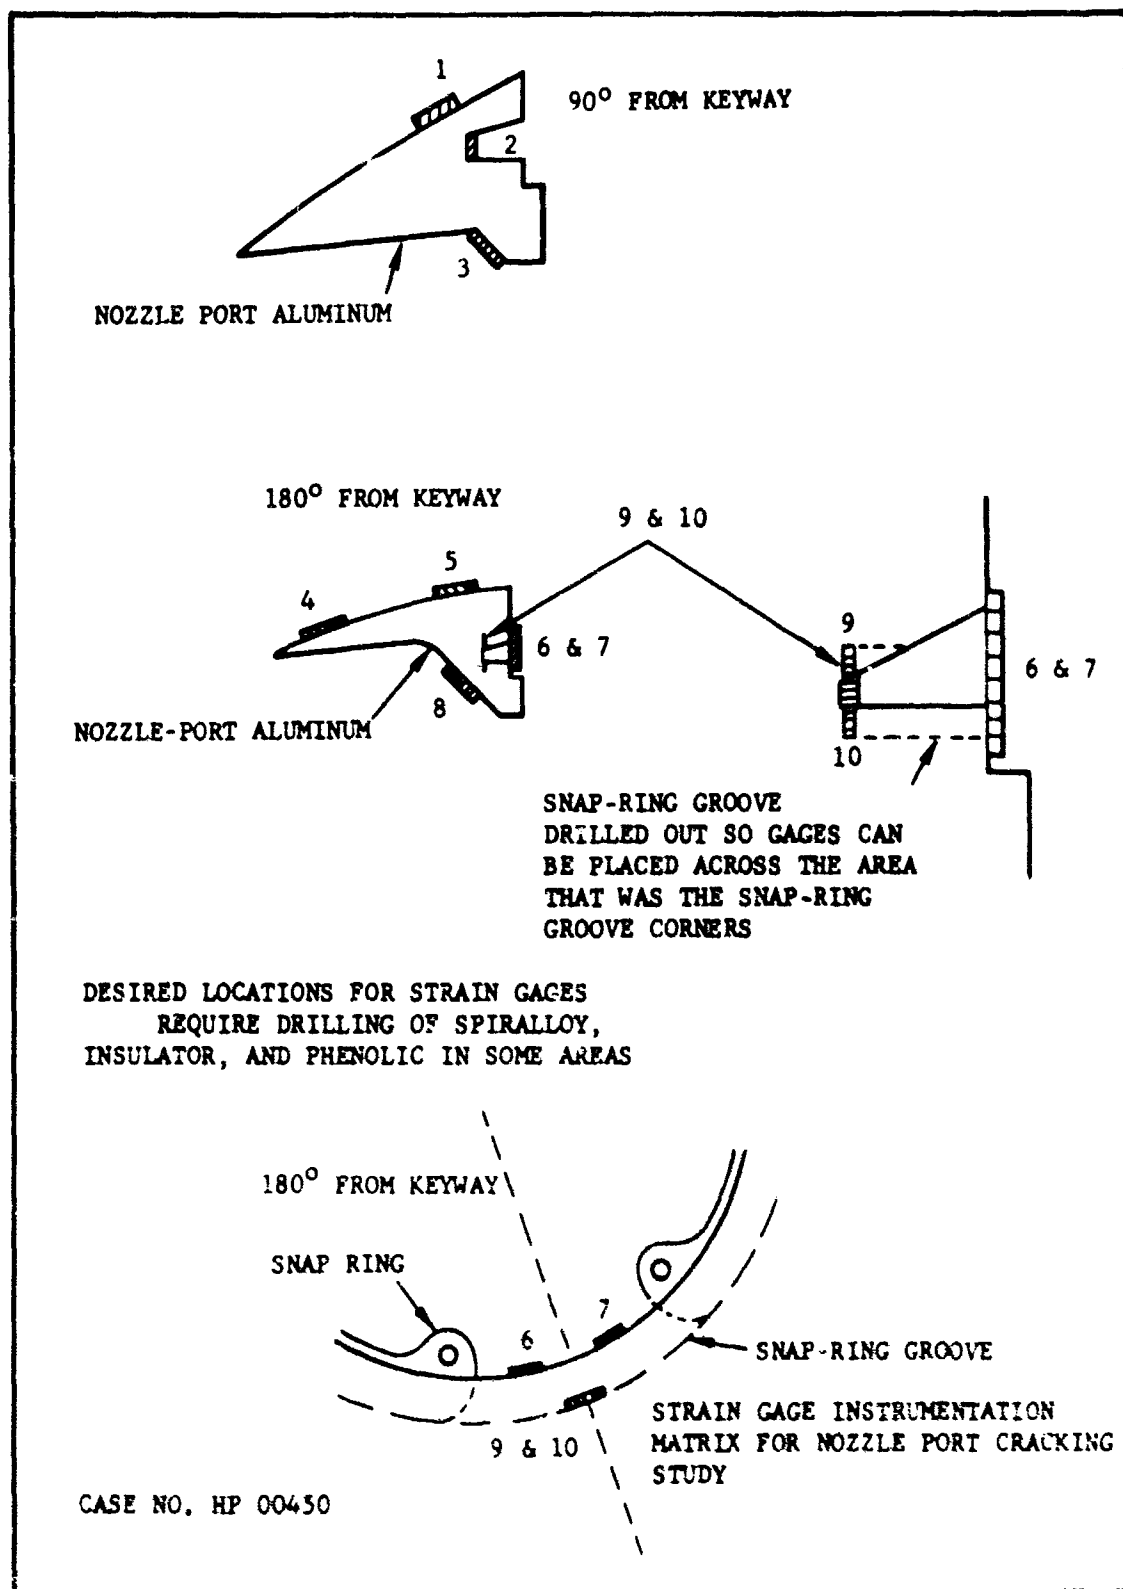
Figure 3. Strain Gage Location,  
Firing Pressure Effects Test

For these purposes, nozzle port number 1 of case S/N HP00450 was instrumented with strain gages as shown in Figure 3. This case had been rejected for operational use because of cracked nozzle-port flanges in ports number 2 and 4. Dye-penetrant and radiographic inspection indicated there were no cracks in the flanges of nozzle ports number 1 or 3.

In order to accommodate installation of the strain gages, 3/4 in. dia. holes were drilled from the interior through the insulator and phenolic at 90 degrees and 180 degrees, clockwise, from the keyway. Strain gages number 3 and 8 were then bonded to the aluminum flange through these access holes. Likewise, at the same degree locations, 3/4 in. holes were drilled from the exterior through the Spiralloy to accommodate strain gages number 1, 4, and 5. The snap-ring groove was drilled out so gages number 9 and 10 could be placed across the area at the base of the ring groove. Four electronic deflection indicators (number 6A, 6B, 7A, and 7B) were substituted for strain gages number 6 and 7.

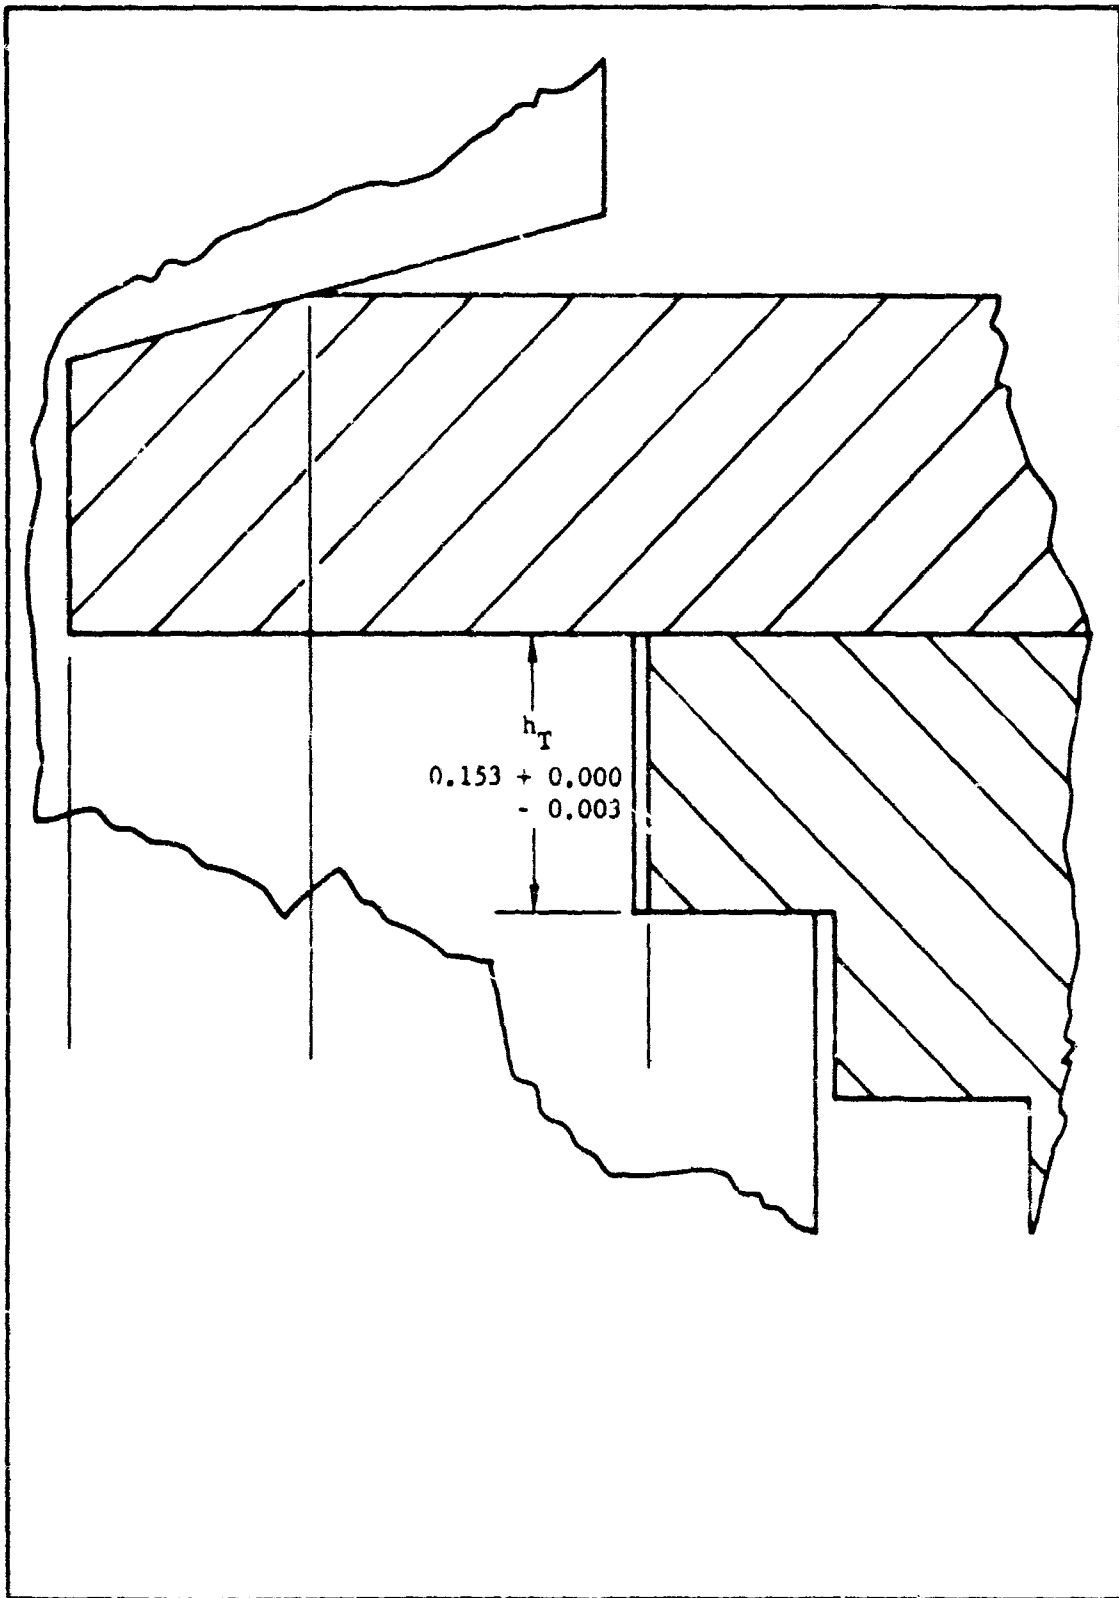
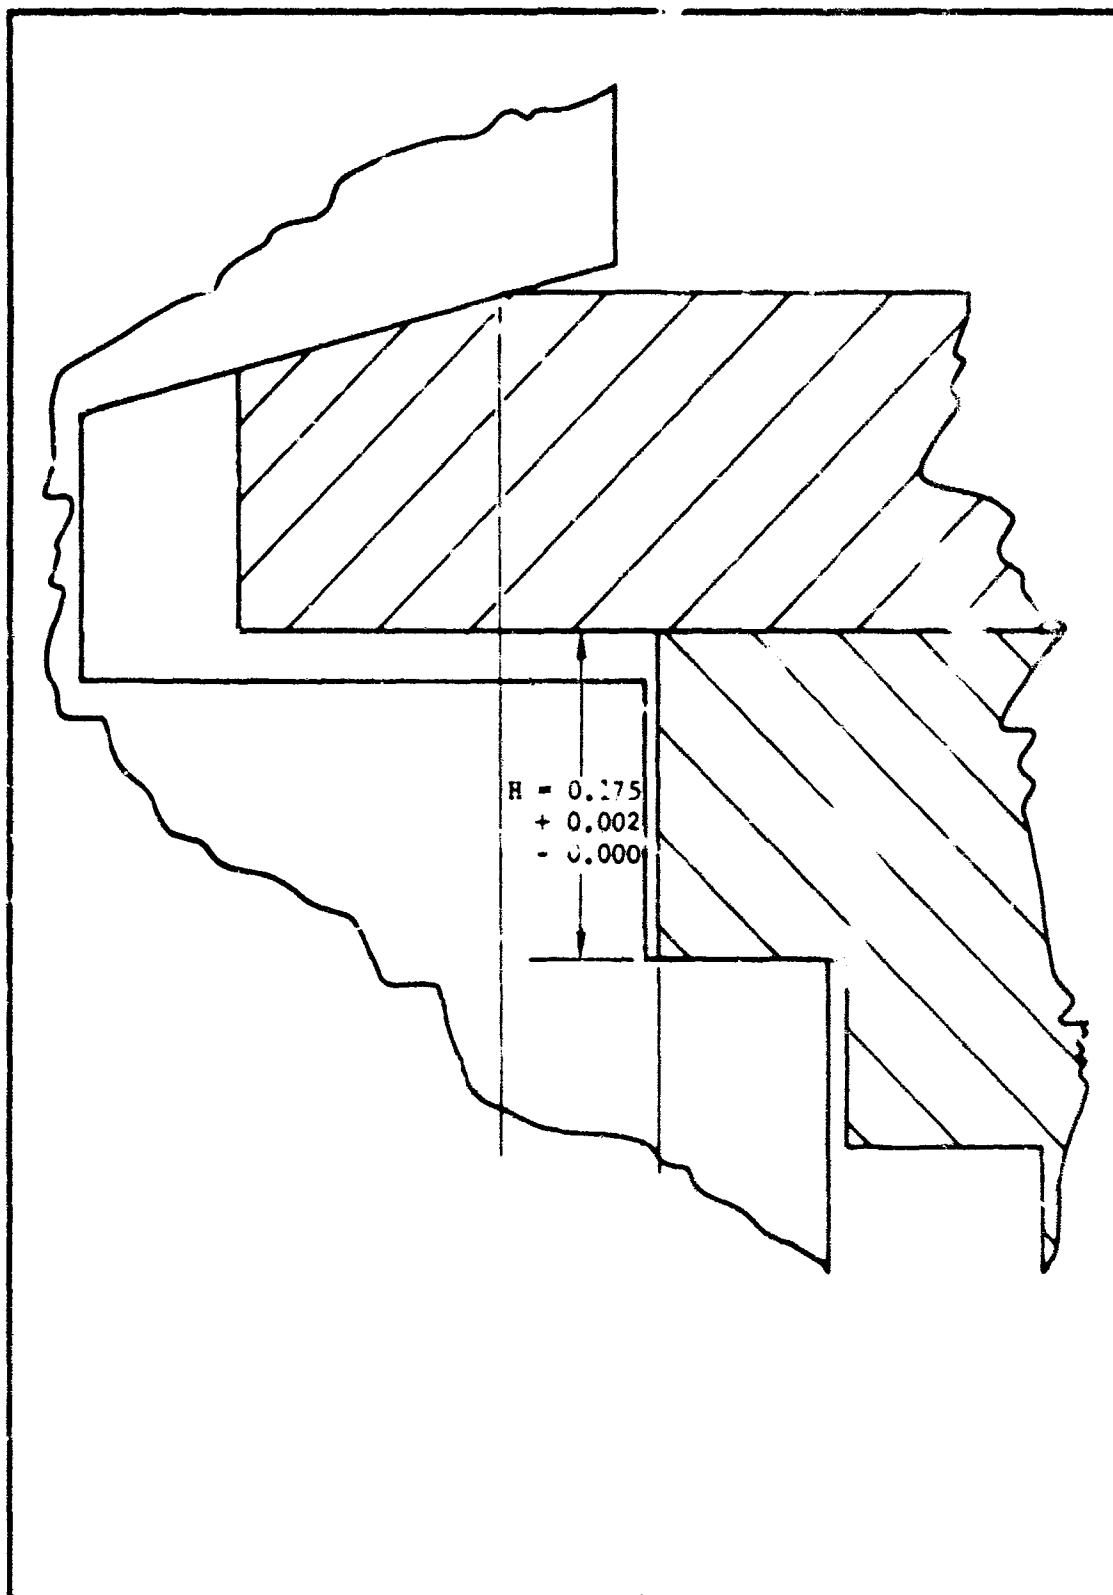
During inspection of the hydroproof closures used for production case testing, it was discovered that the nominal thickness of the closure lip was 0.150 in. This dimension was 0.025 in. thinner than the nominal thickness of the lip on an operational nozzle. Figures 11 and 12 show that the snap ring does not seat as deeply into the snap-ring groove with the operational nozzle as it does with the hydroproof closure.

Figure 11. Original Hydroproof Closure Installation

Figure 12 Operational Nozzle Flange Installation

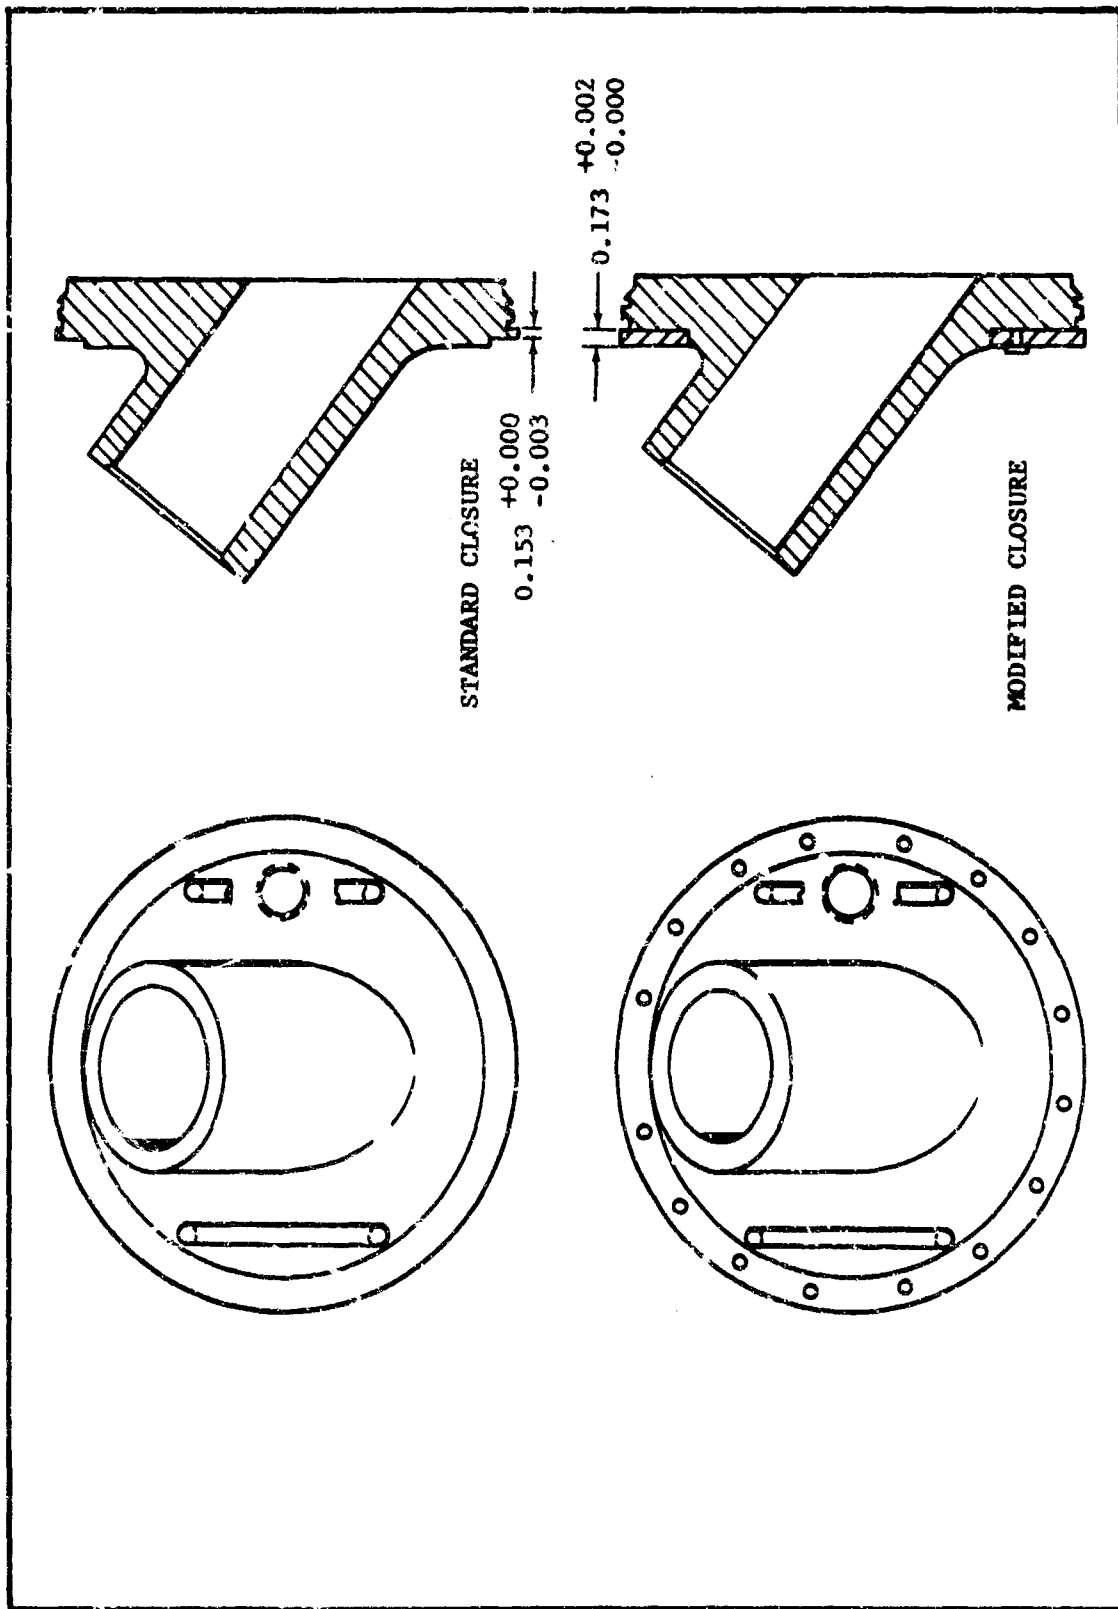
Figure 13. Hydrotest Closure Comparison

The original hydroproof nozzle port closures have a lip thickness dimension of 0.150 to 0.153 in., whereas, the corresponding dimension for the operational nozzle hardware is 0.175 to 0.180 in. Simulated hydroproof loading tests showed that a change in closure-lip thickness had a marked effect on the stresses in the snap ring groove area of a nozzle port flange. The purpose of these tests was, therefore, to evaluate and compare the stresses on a nozzle-port flange during actual hydroproofing with the standard hydroproof closures and with closures modified to correspond to the operational nozzle hardware dimensions. (See Figure 13.)

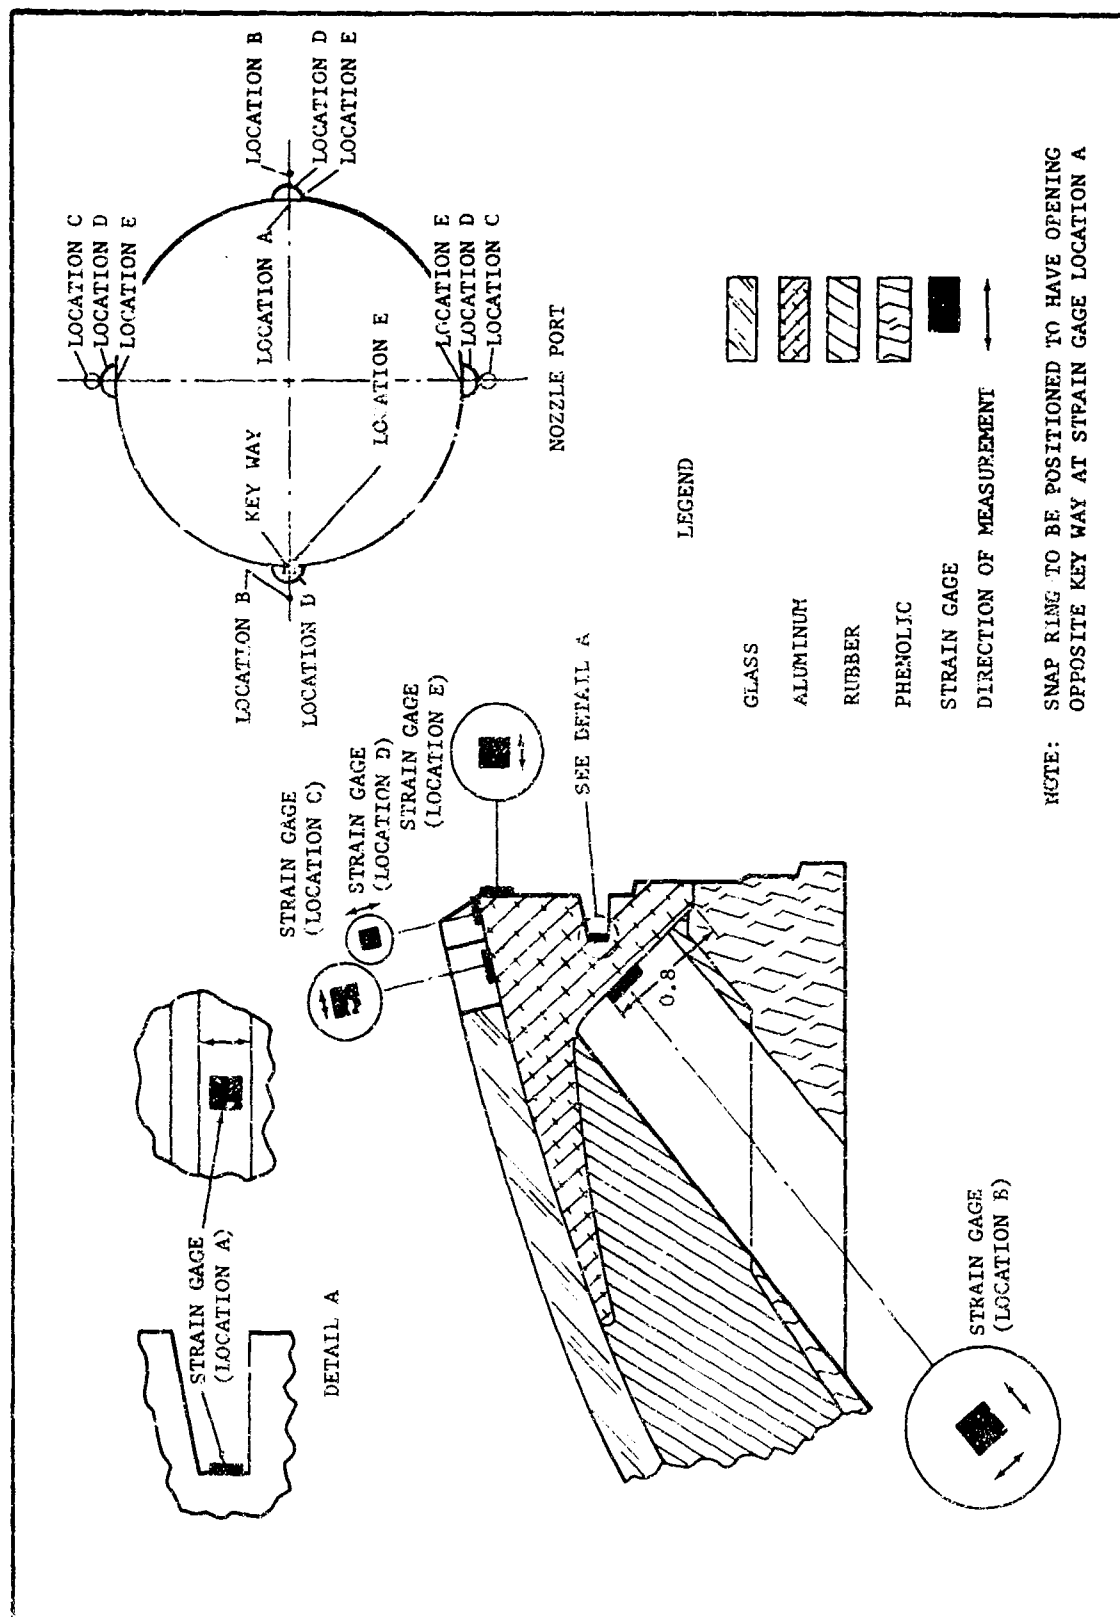
Figure 14. Strain Gage Location, Modified Closure Test

Two ports on each case, determined by dye-penetrant inspection to contain uncracked nozzle-port flanges, were instrumented as shown in Figure 14. Per BSD approval, TWX number BSRKP-3/20811 dated 18 January 1965, additional hydroproof cycles were added to the program plan to test the effect of the turnbuckle assembly, P/N 7480, on flange stresses.

After run number 3, all strain gages in port number 1, test number I and port number 4, test number II did not return to zero thus indicating yielding of the flange in some area. Dye-penetrant inspection of nozzle port flanges in these two ports revealed typical snap-ring groove cracks.

On tests number III and IV, the closure sequence was reversed using the standard closure for the first cycle. Inspection of the instrumented flanges after the first run showed that on test number III both flanges were cracked, and on test number IV one flange had cracked during the hydroproof cycle. Two subsequent runs with modified closures on test number IV, however, did not crack the nozzle-port flange that survived the standard closure run.

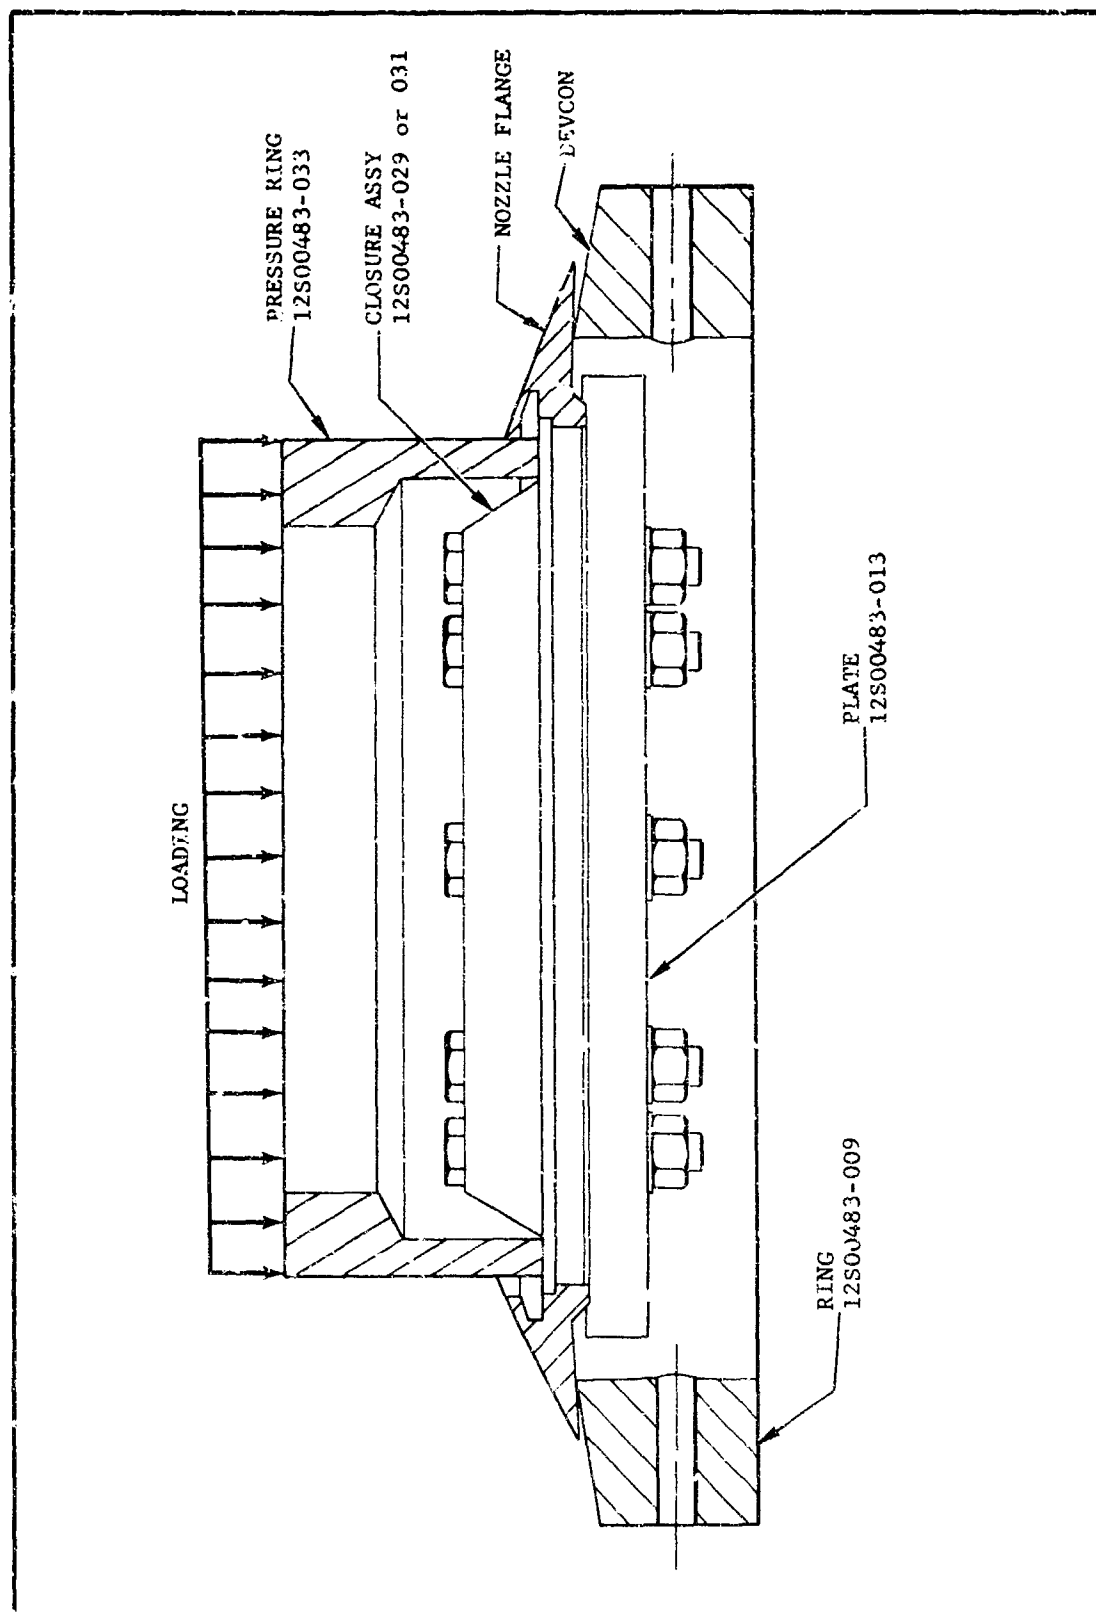
Figure 16. Molding Effect Test Configuration

An analysis of the test fixture revealed the Devcon support ring (Figure 16) had been molded to the contour of the Goodyear control flange (S/N GY01929), and the resulting mismatch between the ring and the other test flanges caused areas of high localized stress.

A rerun of the 40,000 pound comparative load tests, using a Devcon support ring formed to each flange contour, showed the maximum strain averaged for both sides of the flange to be nearly equal for all flanges, indicating no measurable strength degradation of the flanges tested in this series.

Further analysis of the mismatch of contours between the support ring and flange indicated that similar localized stress areas would be produced during actual insulator dome molding if there was a mismatch between flange and mold contours.

Additional testing of this mismatch, or gap effect, showed a marked increase in strain as the gap increases. For example, on a new hand forged flange, S/N GY01940, the strain increased approximately 0.002 in/in. for each 0.010 in. increase in gap between the flange and support ring contours.

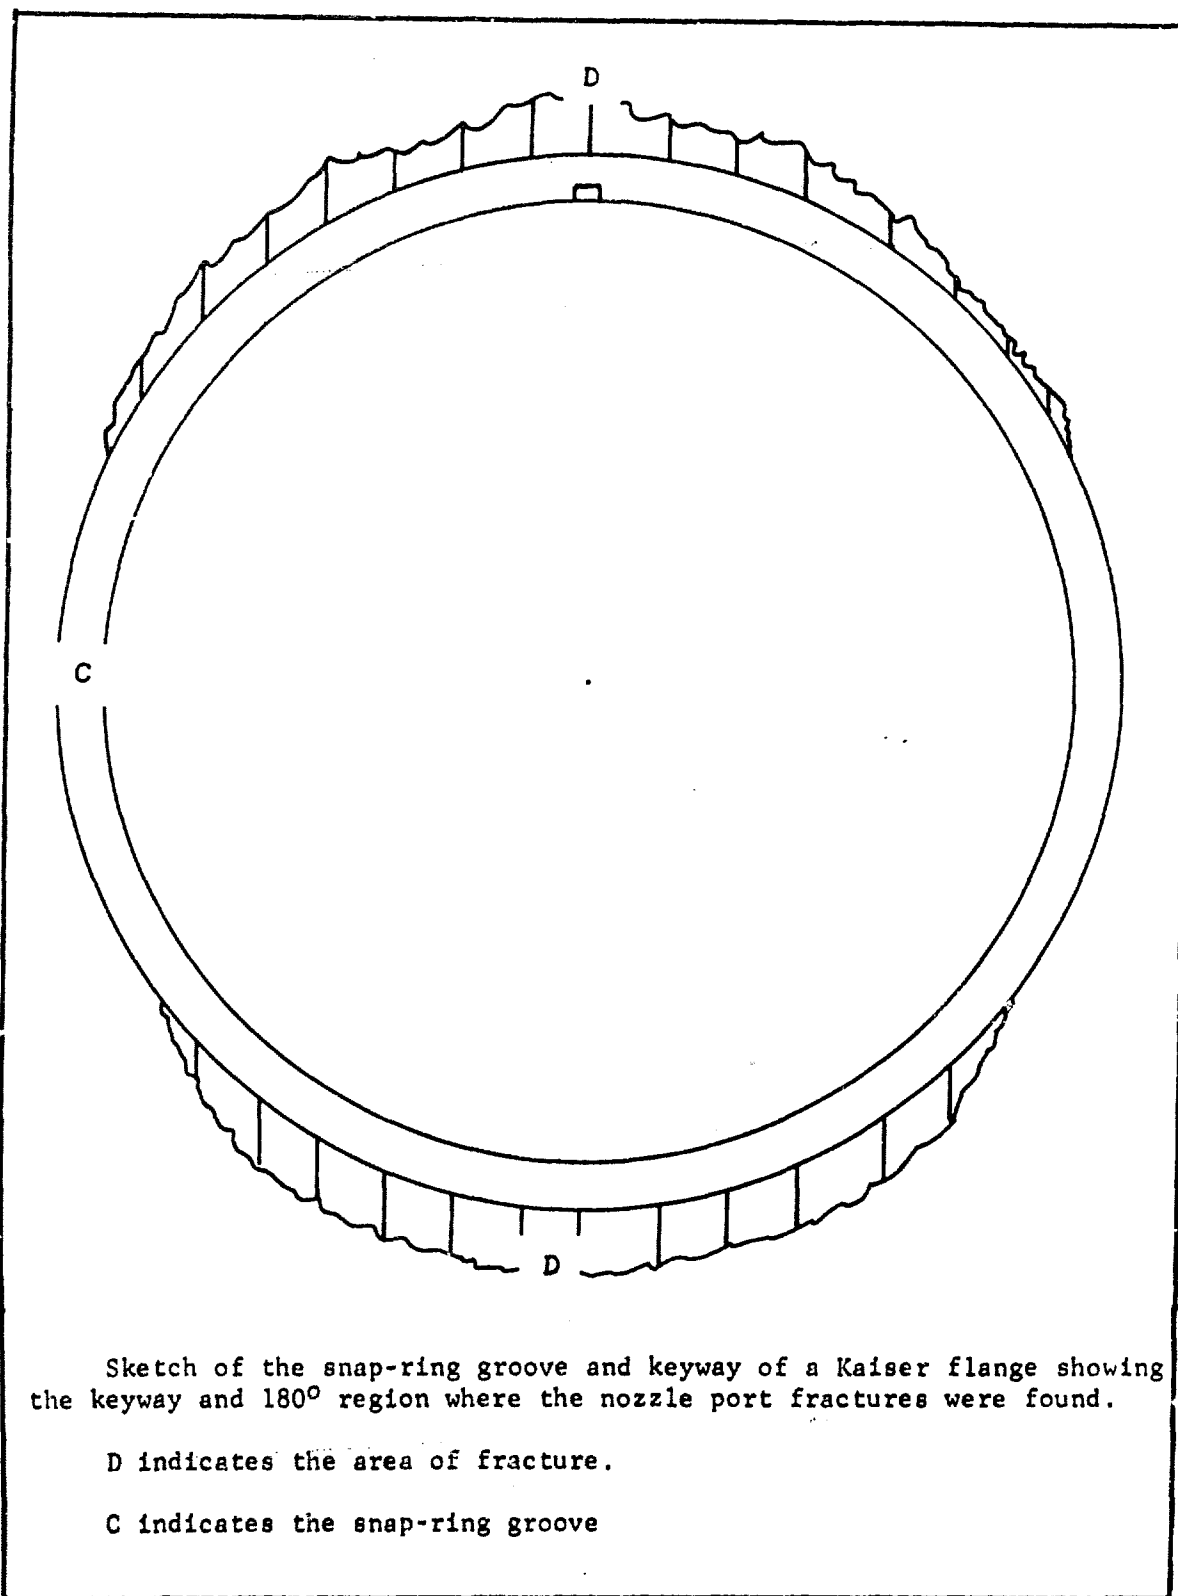
Figure 24. Fracture Regions

Shown (approximately 1/5 actual size) is adapter GY 02508 from Case HP 00429, Nozzle Port 3. The original failure extended from (1) to (1') on the figure. The bright edge indicated by arrow (2) is where shear failure occurred when the fracture was mechanically exposed for surface examination. Arrows (3) point to small shiny, irregular areas extending into the failure surface from the inside edge of the snap-ring groove. These are indications of stress corrosion cracking. The fracture originated in these areas.

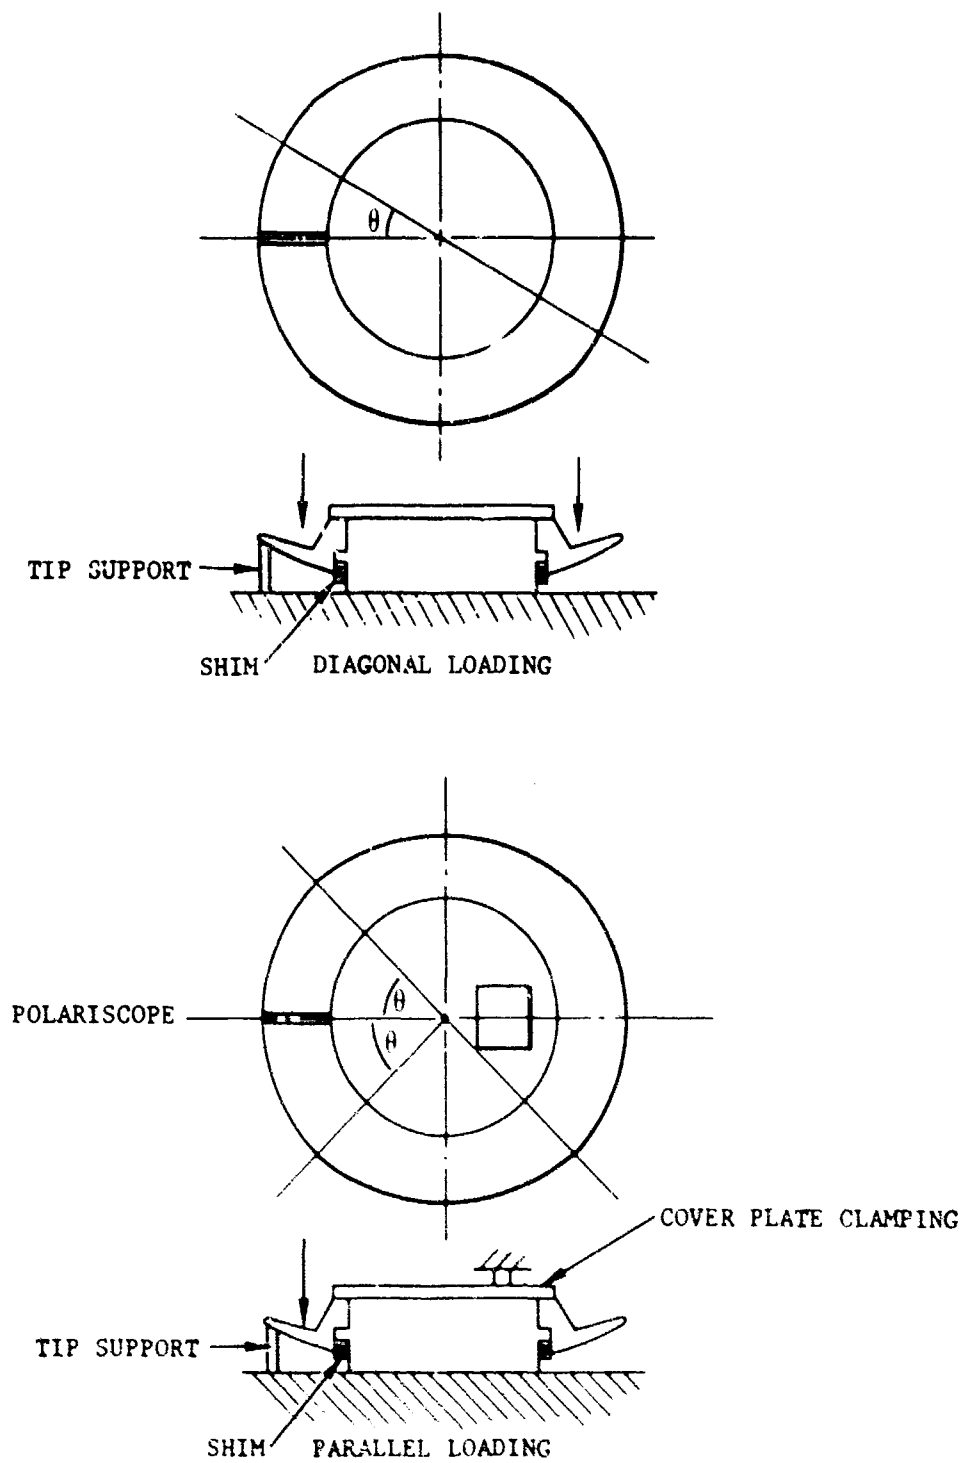
Figure 37. Shimming Support

Zyglo and metallurgical tests performed after molding indicated no cracks or stress corrosion in any of the flanges.

- a. A .081 in. shim was placed on each mold insert, thus leaving approximately 0.020 in. expansion gap between the mold insert and the cooling plug.
- b. After insertion of the cooling plug in each flange, gaps were shimmed between the flange and the cooling plugs on the 10.530 in. diameter. (See Figure 37.) Shimming supports the flange against the cooling plug during molding and reduces the stress in the corner of the snap ring groove.
- c. The four one-inch bolts were torqued to 400 in.-lbs to fully seat the flange in the mold, then loosened and retorqued to 150 in.-lbs.
- d. After assembling the flanges in the mold, each 3/8 in. bolt was loosened approximately one-half turn to allow the cooling plug to move with the flange, thereby eliminating stress on the step from the 10.300 in. to the 10.500 in. diameter of the flange.

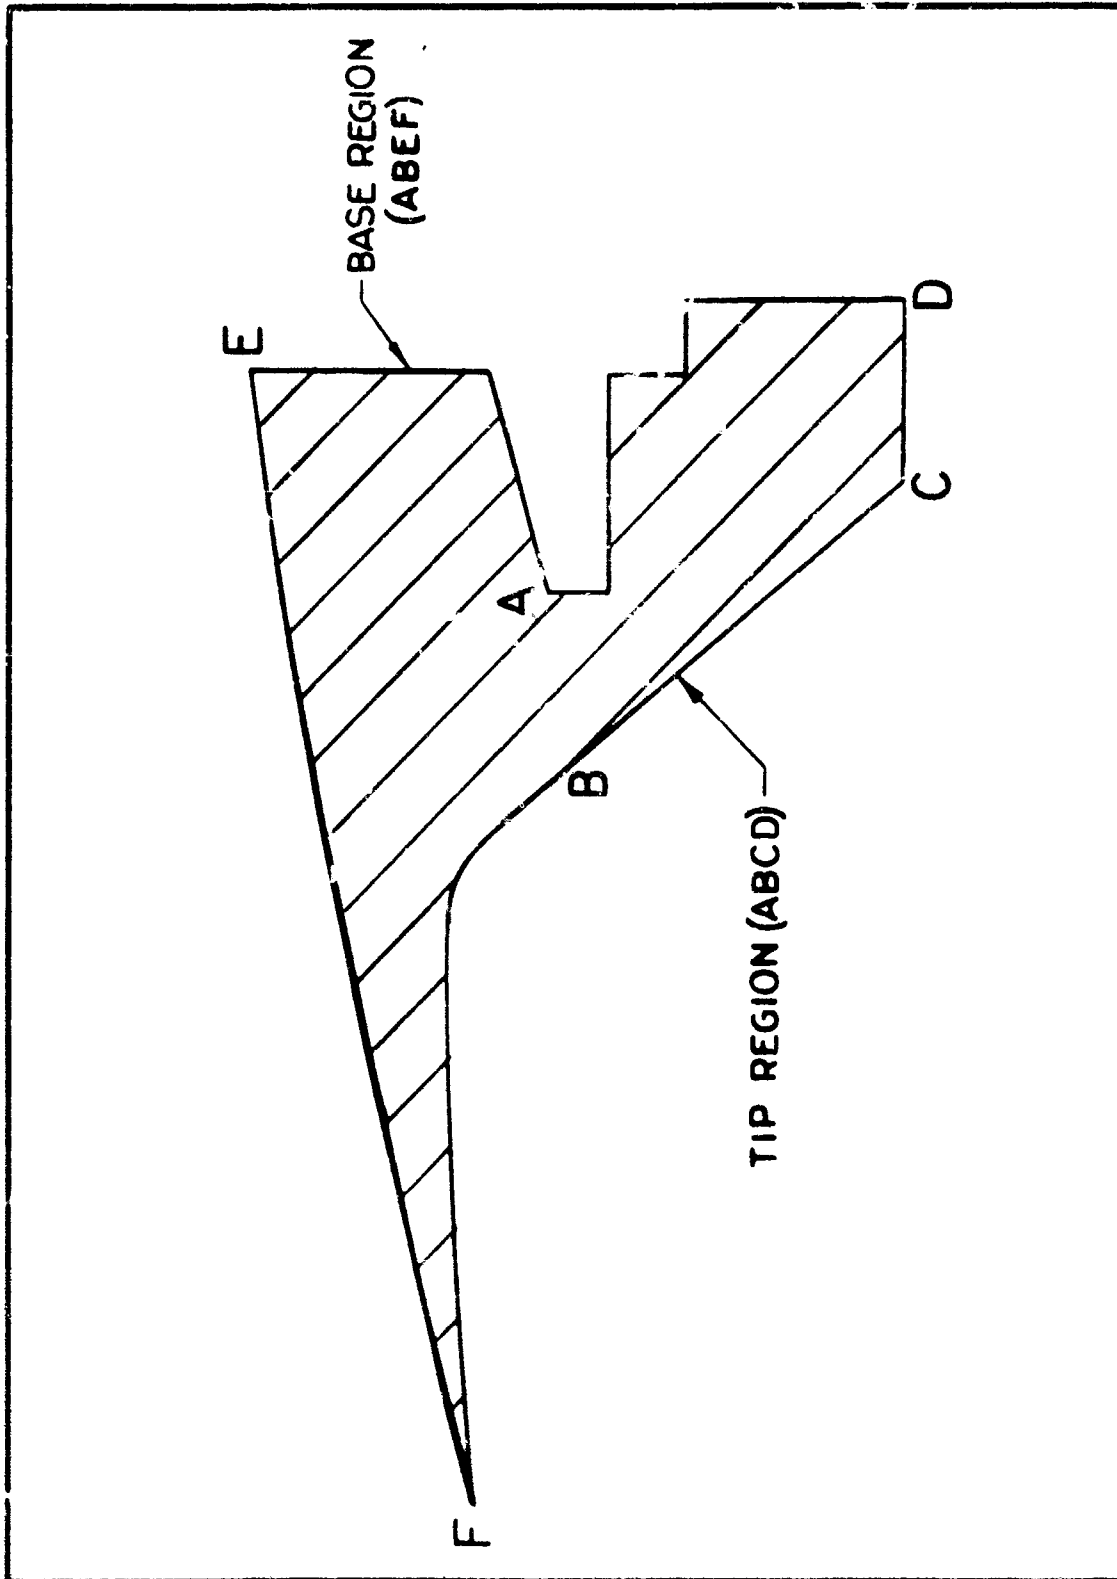
Figure 38. Geometry of Flange

In conducting this analysis, a pressure of 350 psi was assumed to be a representative level for evaluating the structural integrity of a flange as a device for resisting outward motion of the rocket nozzle during flight. It was further assumed that the tip region of the flange had been completely broken off at the forward radius of the nozzle snap-ring groove, leaving only the base region to resist the snap-ring force. (See Figure 38.)
